Thermal fatigue led to gas plant fire and explosion, CSB says

David Wagman | April 03, 2019

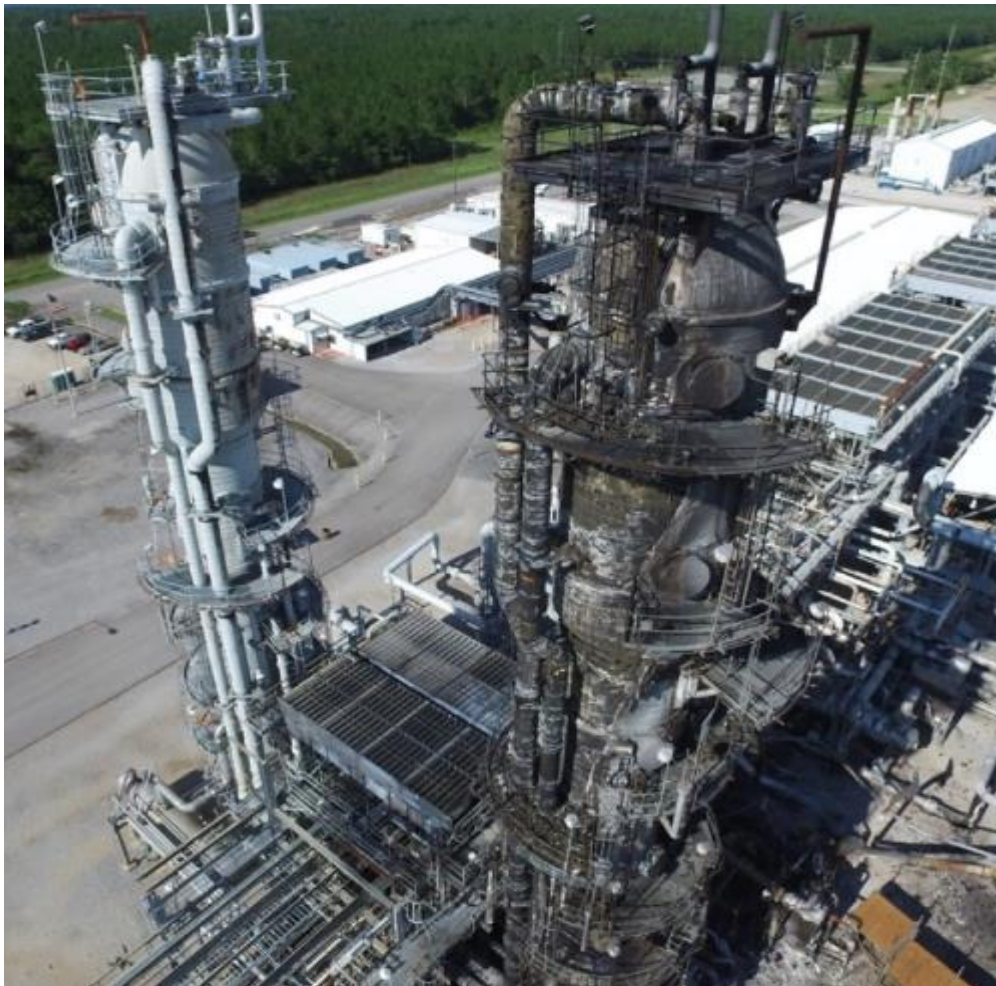
Thermal fatigue was a root cause of a 206 fire and explosion at a gas processing plant.

A piece of equipment used in the process is a brazed aluminum heat exchanger, which allows for the transfer of heat between two different process streams while keeping the streams separate. The CSB investigation determined that the probable cause of the incident was a

failure of the heat exchanger due to thermal fatigue. The report said that as the exchanger is heated or cooled, its tightly connected parts expand or contract.

If the parts change temperatures at sufficiently different rates, the expansion and contraction can be disproportionate. Over time, this process weakens the metal, and ultimately causes cracks, which can lead to the escape of hydrocarbons. Typically, when a leak is found, it can be repaired before a major loss of containment occurs. The CSB said that thermal fatigue is a known factor to brazed aluminum heat exchangers and industry guidance offers recommended limits for maximum cyclic temperature fluctuations during operation and rates of cooling or heating during start-up and shutdown. However, the CSB found in its investigation that this guidance was not robust for the diverse operations and environments where that type of heat exchanger operates.

At the Enterprise Gas Plant, process data for the exchangers show that the equipment was repeatedly subjected to temperature changes that exceeded industry-recommended practices. That increased stresses on the connections within the heat exchangers as the aluminum parts pushed against and pulled apart from each other. At Enterprise, over a 17-year period, four different brazed aluminum heat exchangers were repaired nine times, the accident report found.

The 2016 accident, along with four other failure events at other facilities, suggest that relying on a so-called leak-before-failure assumption is not adequate, the CSB said. "Operators of midstream gas plants need a more robust assessment and risk management plan that considers thermal fatigue to prevent the risk of sudden and catastrophic rupture" brazed aluminum heat exchangers, it said.

Investigator William Houglund said, "A number of midstream gas plant operators have reported that the limits and rates in existing industry guidance may not be realistic. The CSB concluded that more realistic and updated guidance is needed to improve the safe use of BAHX." (Learn more from IEEE Engineering360 about [standards](#) related to heat exchangers.)The CSB issued recommendations to two trade associations, the American Petroleum Institute and GPA Midstream Association, to share information related to failure hazards of brazed aluminum heat exchangers from thermal fatigue.
